UTW In California and Nevada
A 13-Year Performance Perspective of Performance Based on Joint Spacing, Thickness, and Traffic Loading
By David J. Akers, PE
California Nevada Cement Association

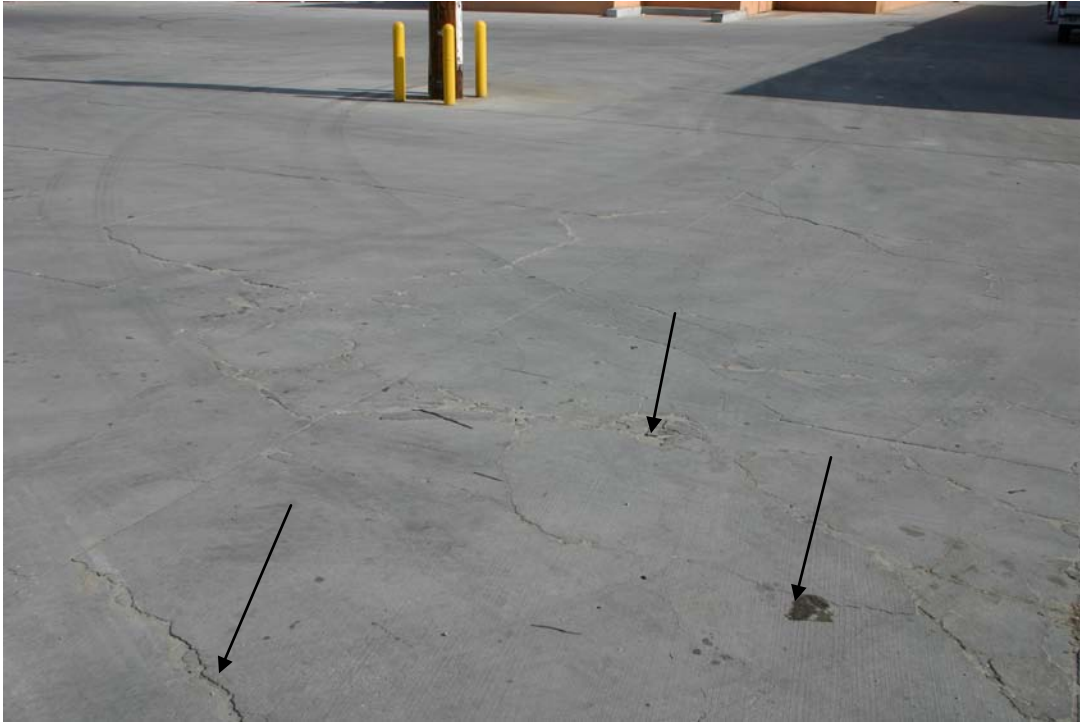
Photograph B Indio Heights Center – Cracking at truck unloading/loading area

Of the ten projects having wide joint spacings, the two that have the highest equivalent single axle loads and lowest PCI’s also are subjected to regular truck traffic. The Indio Heights Center is a strip center on the westerly edge of Indio, CA. Semi-tractor delivery trucks and trash trucks have severely impacted a small section of UTW at the back of the stores (Photograph B). The public parking areas are not notably distressed. For comparison, Photographs C and D of the Palm Springs Library parking lot show the wide joint spacings and minimal panel distress, respectively.

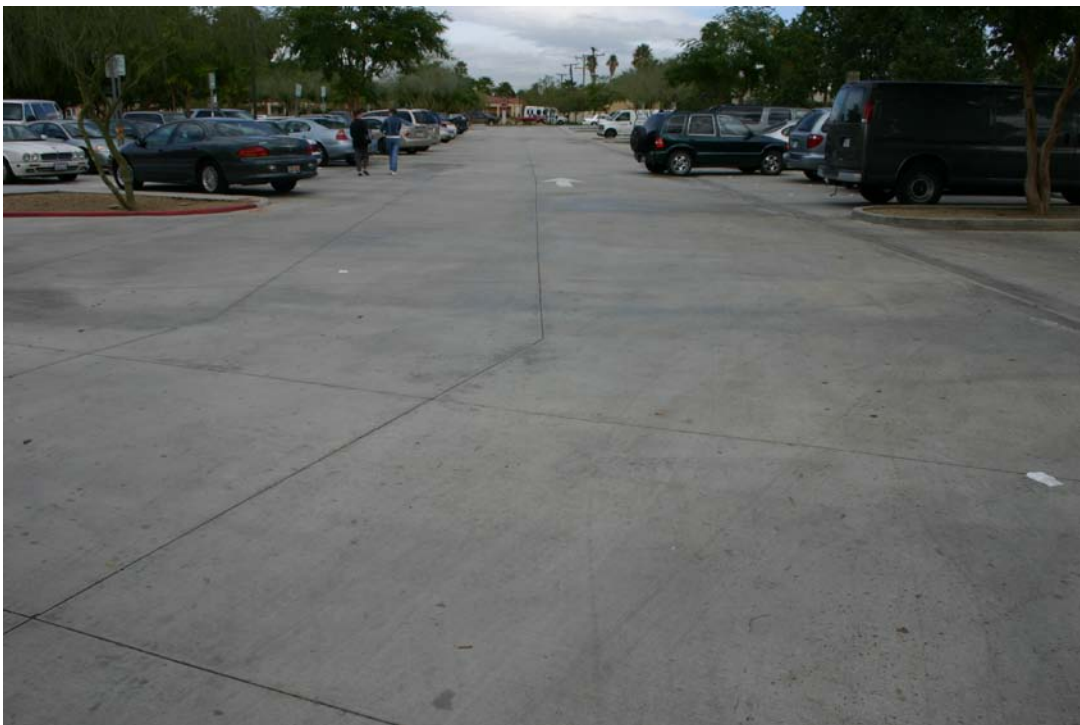
Photograph C Palm Springs Library Parking Lot

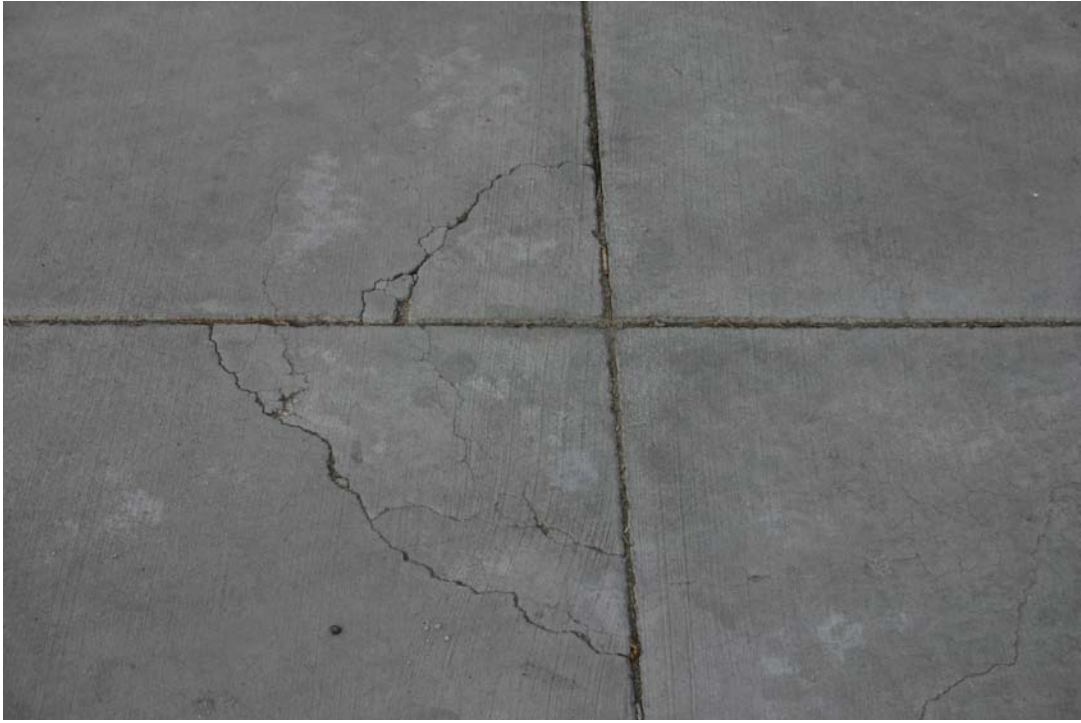
Photograph D Largest Crack in Palm Springs Library Parking Lot

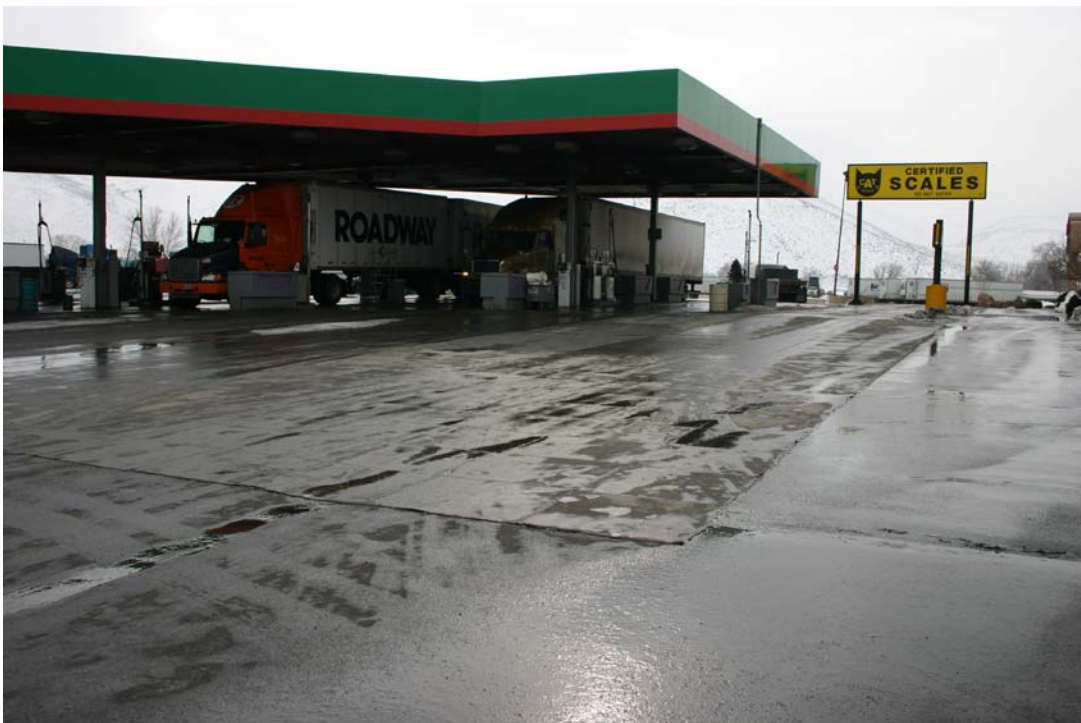
Photograph E Alamo Truck Stop – UTW extends from scale and from pump island adjacent to scale

The eight UTW projects constructed using conventional joint spacings are subjected to varying amounts of truck, bus, and car traffic. The Alamo truck stop UTW spans both the truck scale exit and a fuel island lane (Photograph E). While this project exhibited minimal cracking, the cracks were concentrated on the scale side of the pavement (Photograph F). It was noted that from a dead start, the tractor/trailer's start is not uniformly smooth and even. The initial forward motion creates a bobbing or bouncing effect. For a tractor transitioning from the scale to a solid surface, the bouncing effect is magnified and creating distress in the wheel path. No such distress was observed in the fuel lane UTW.

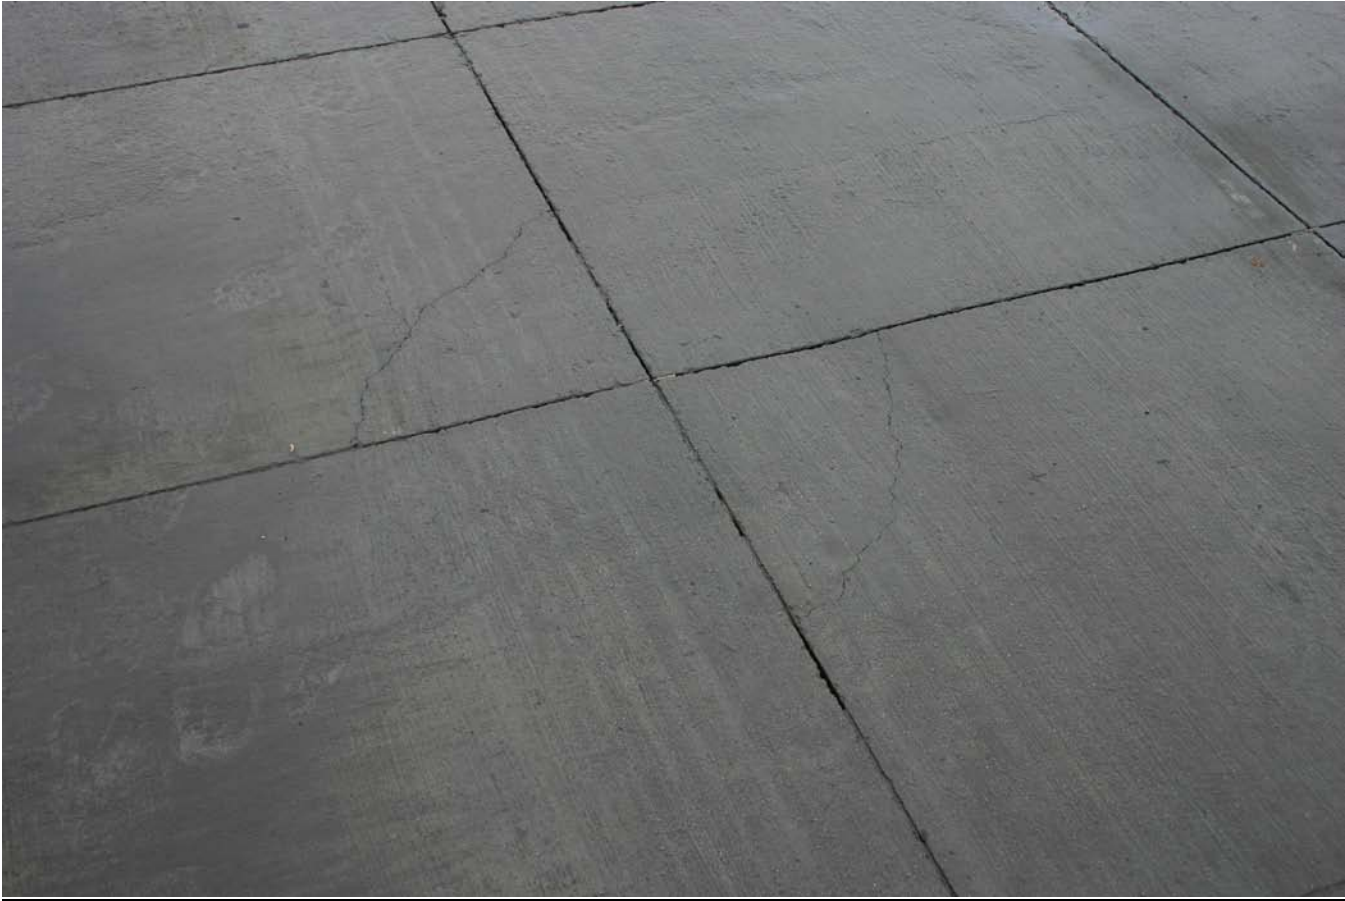
Photograph F Alamo Truck Stop – Corner breaks in UTW in portion extending from scale

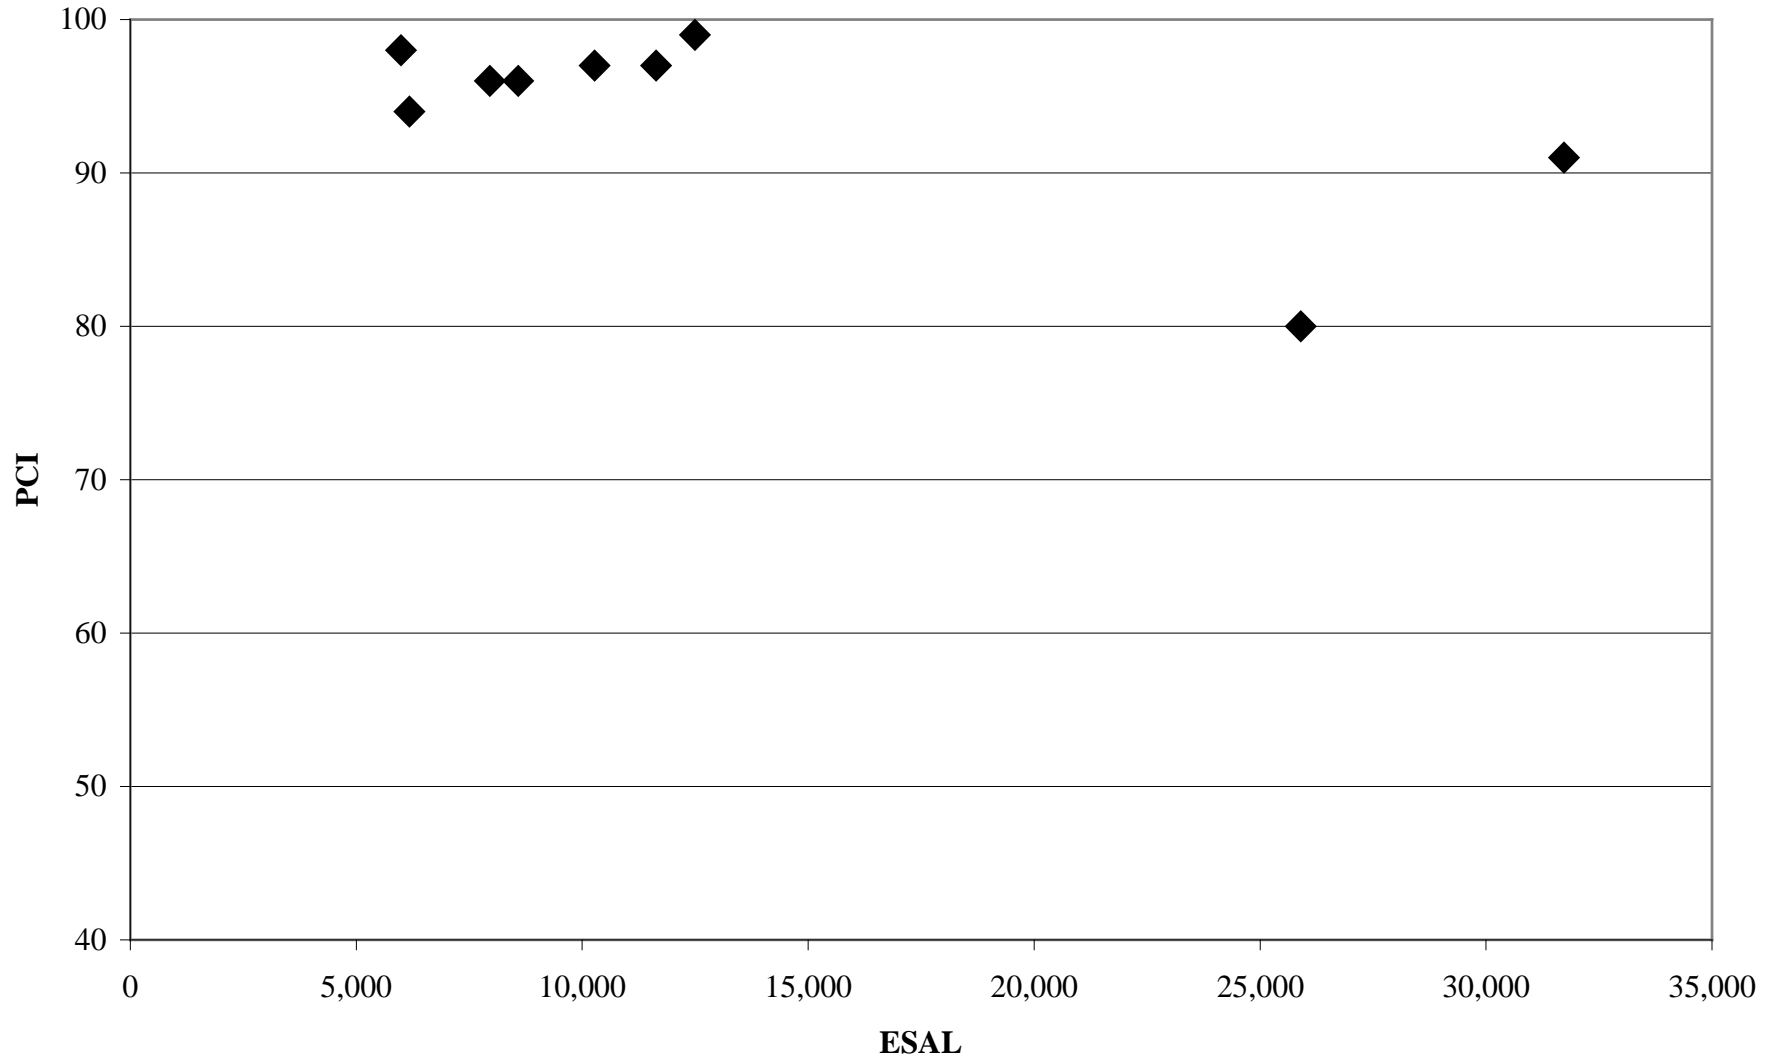
The graphical comparison of the PCI to the accumulated ESAL's for the ten projects with wide joint spacings illustrates excellent performance (Figure 1). The single outlier is the mortuary. Had the sawn joints been continued into the last three panels, the cracks most likely would not have occurred and the PCI would be significantly higher. As previously noted, the cracks are stable in width and length and the UTW is not delaminated from the underlying asphalt concrete pavement.

Figure 1 PCI v. Accumulated ESAL's - Oversize Panel Spacing
